Safety Alert 022

Title: Bosch/Neff gas hob product modification

Date issued: 22 February 2017

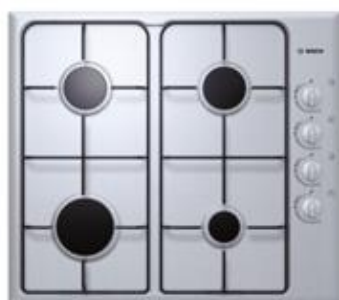
NGU4151DB - Bosch
FD 8901 - 9110

BSH Home Appliance Ltd (BSH) has initiated this precautionary measure as, during comprehensive product monitoring and detailed research, BSH identified a potential issue regarding the gas connectors. In particular circumstances the gas connector can crack or break, which could result in an escape of gas.

BSH is offering every owner of an affected appliance a free replacement gas connector by an authorized service engineer at the owner's home.

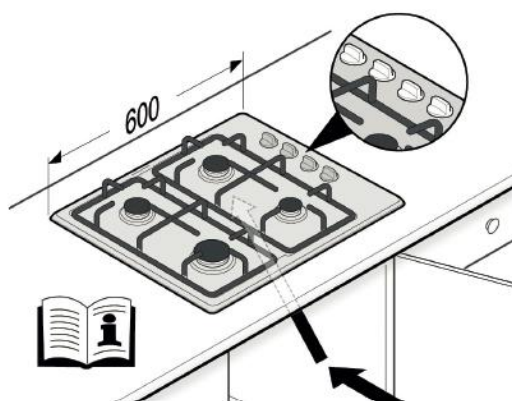
Note down the model number (E-Nr) and batch number (FD) on the rating plate on your appliance or original user manual.

Check underneath of appliance or original user manual.
