# **Technical Bulletin**

## **Cooker Hoses and Flexible Connections**

**BACKGROUND:****Deterioration of LPG flexible connectors**

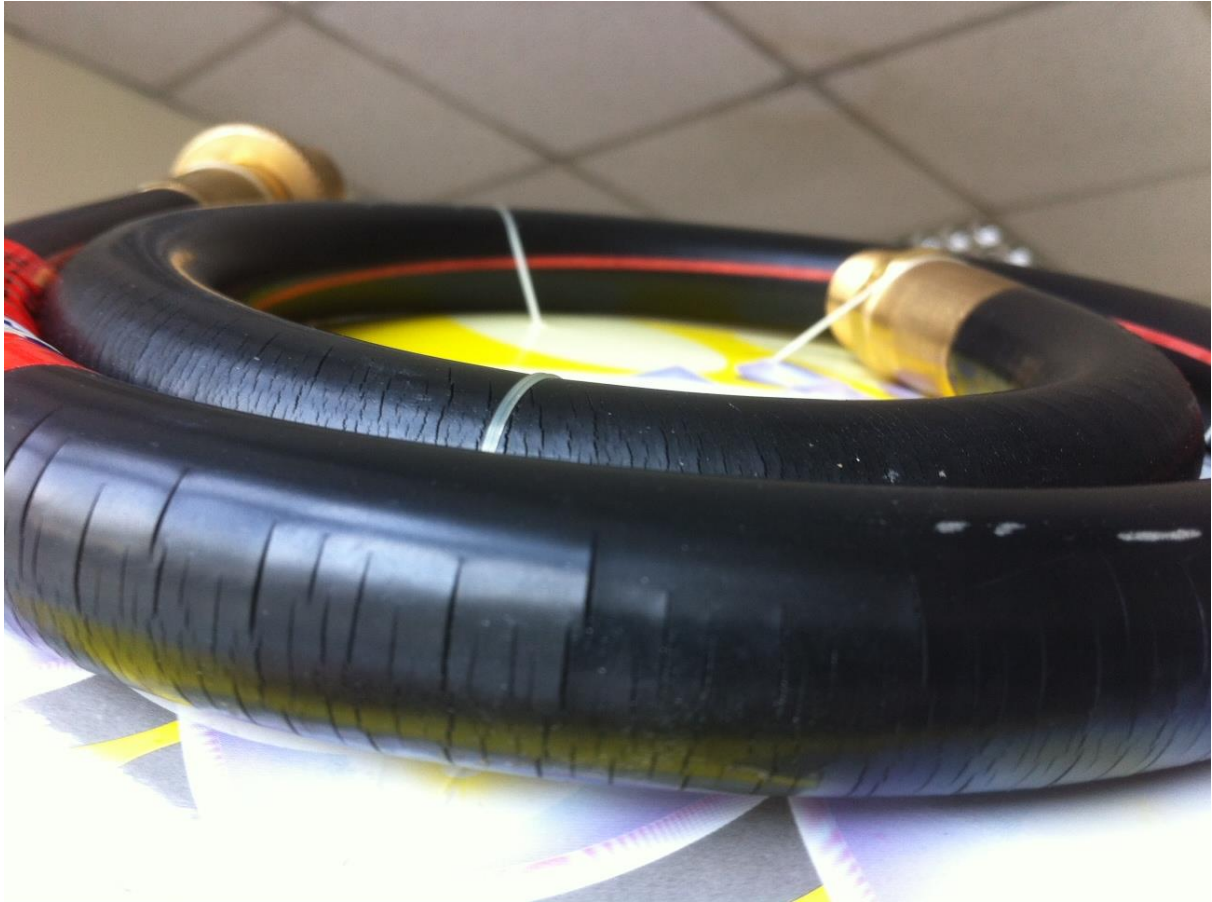
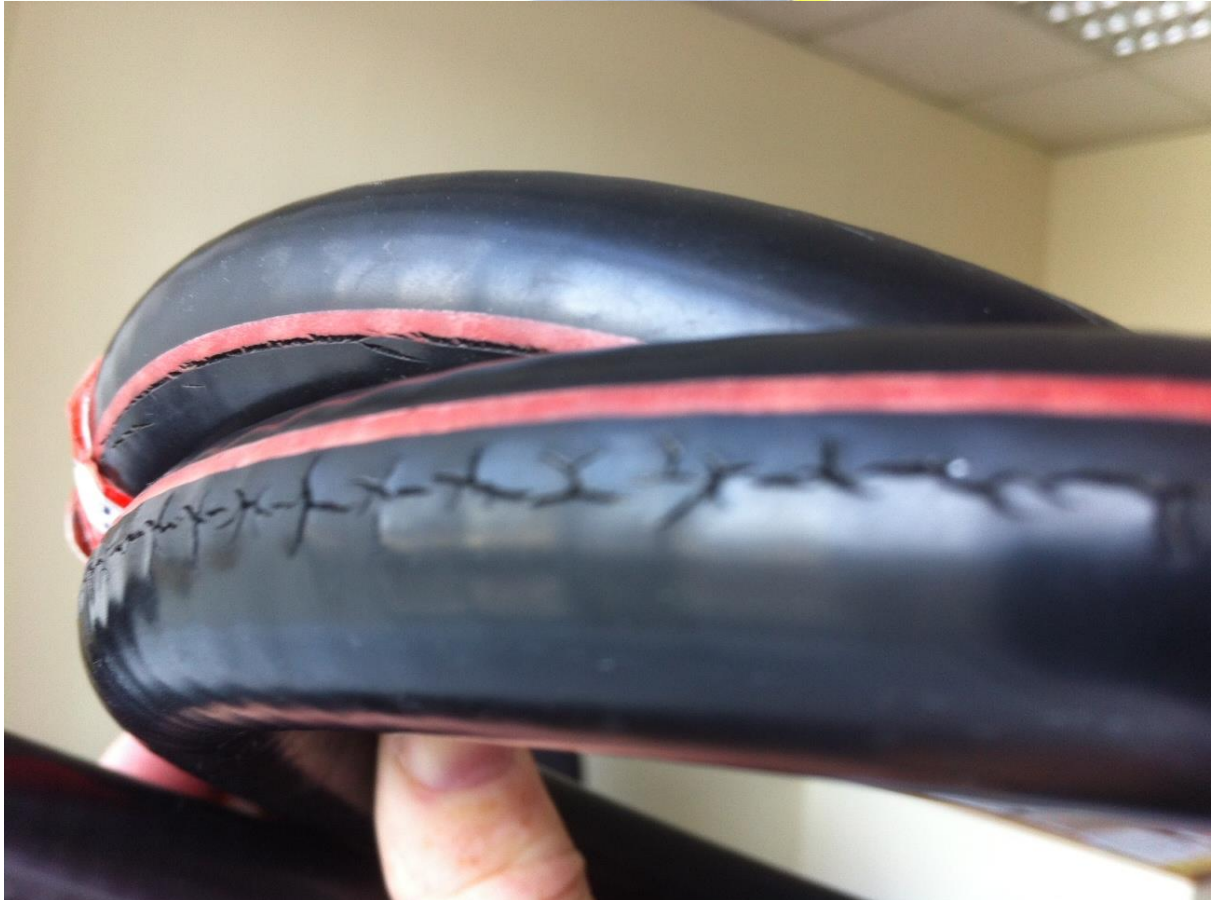
Recently there have been a number of instances reported to RGII of LPG flexible connectors showing evidence of cracking of the outer rubber cover of some LPG cooker flexible connections. In some instances gas escapes have been identified in association with the deterioration of the outer covering, or end connections of these hoses.

In all instances where there are signs of damage, hardening of the outer rubber or where signs of cracking is identified the flexible connection must be replaced immediately with a connection conforming to EN14800

It's important to check flexible connectors held in stock for signs of damage, hardening of the outer rubber or cracking and return them to supplier where appropriate.
