# Title: Grundfos CONLIFT Condensate Pumps - Recall

## Date issued: 11 June 2015

This Safety Alert provides guidance to Gas Safe registered businesses/engineers on a product safety notification recently issued by Grundfos on early models of their CONLIFT condensate pumps produced on or before week 47 of 2007.

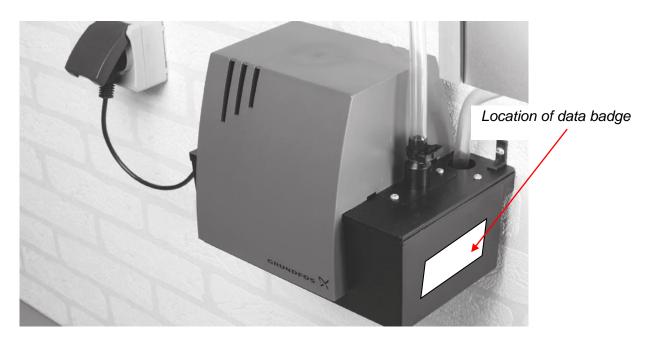
The date of manufacture of the pumps can be found on the data label located on the side of the unit as indicated in **Figure 1**.

**Figure 1** shows a photograph of the affected pump. Each pump is fitted with a data badge located on the side of the unit.

Figure 1 – Showing a Grundfos CONLIFT condensate pump.

To identify if a CONLIFT pump is affected by this Safety Alert, check the date of manufacture. If it is found be within the range as described above, the pump will be required to be replaced.

The product needs to be replaced when the date indicates **0747** (week 47 in 2007), or before.
